Franklin Parker Preserve

New Jersey Conservation

NJCF has partnered with the USDA – Natural Resources Conservation Service (NRCS) to restore all 1100 acres to naturally functioning wetlands. NRCS has committed \$1.25 million for the project.

Construction on the first 86 acres was done in September of 2007. NJCF's contractor worked for 3 weeks using up to six machines at a time.

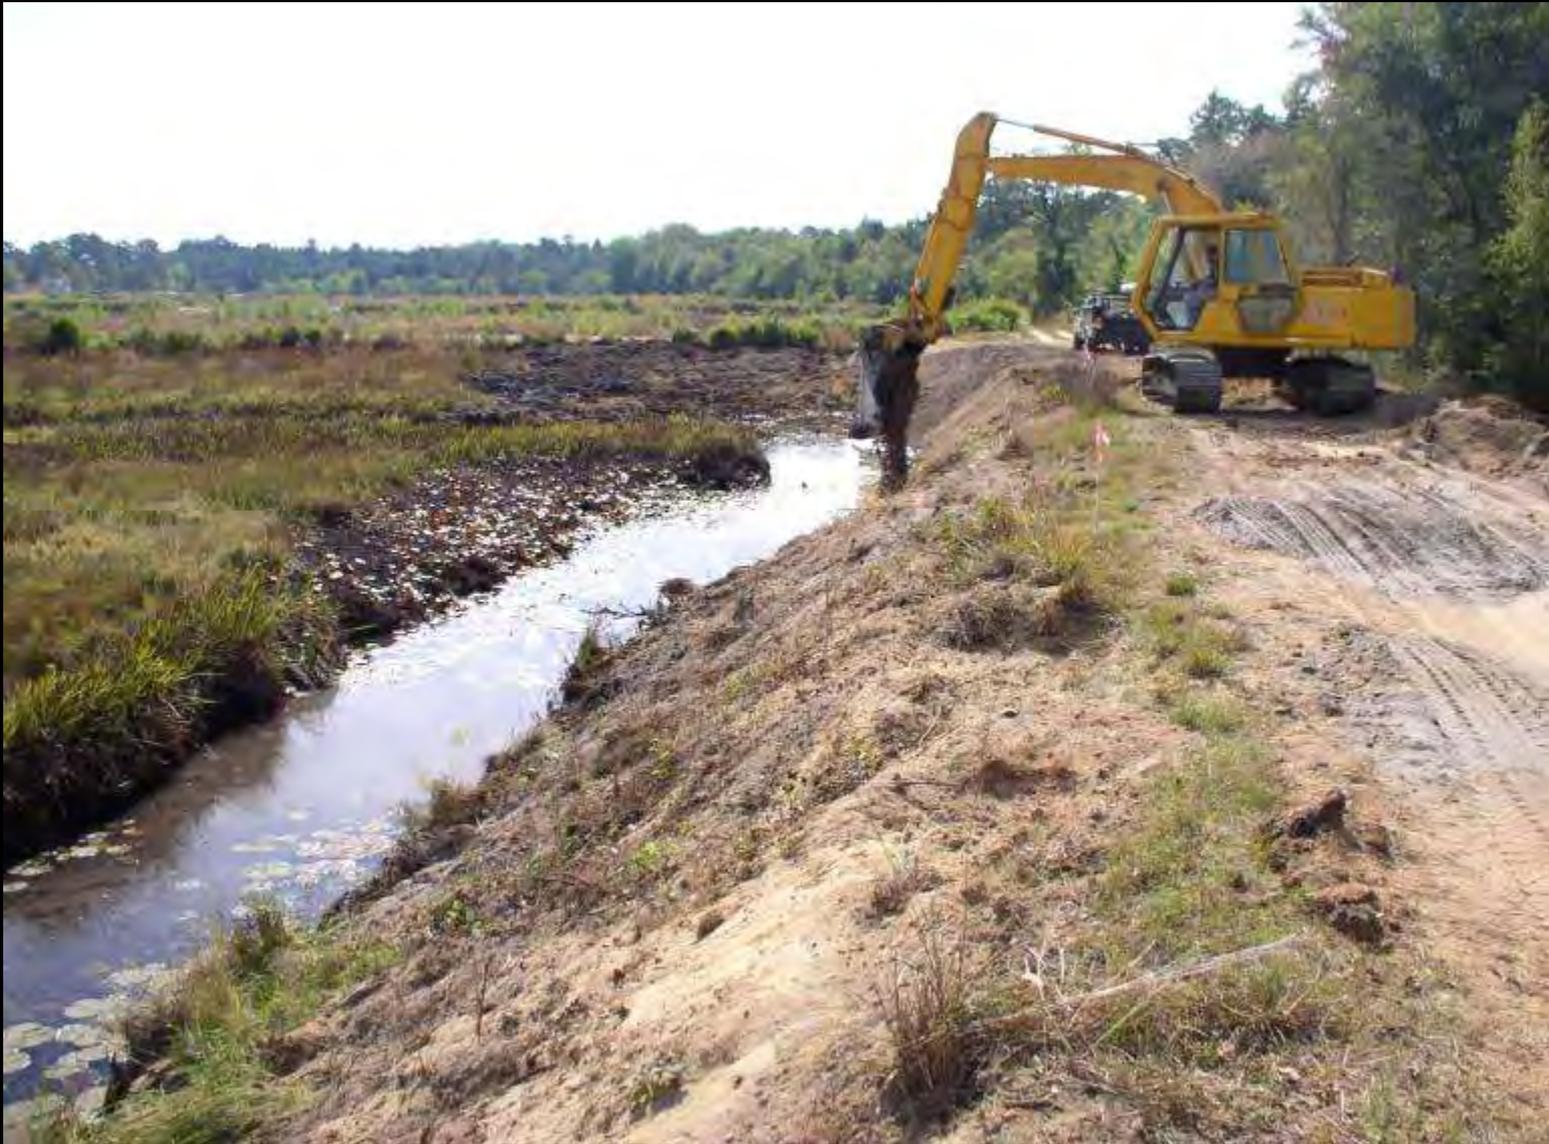
Drainage ditches were plugged so that water is no longer easily drained from the site.

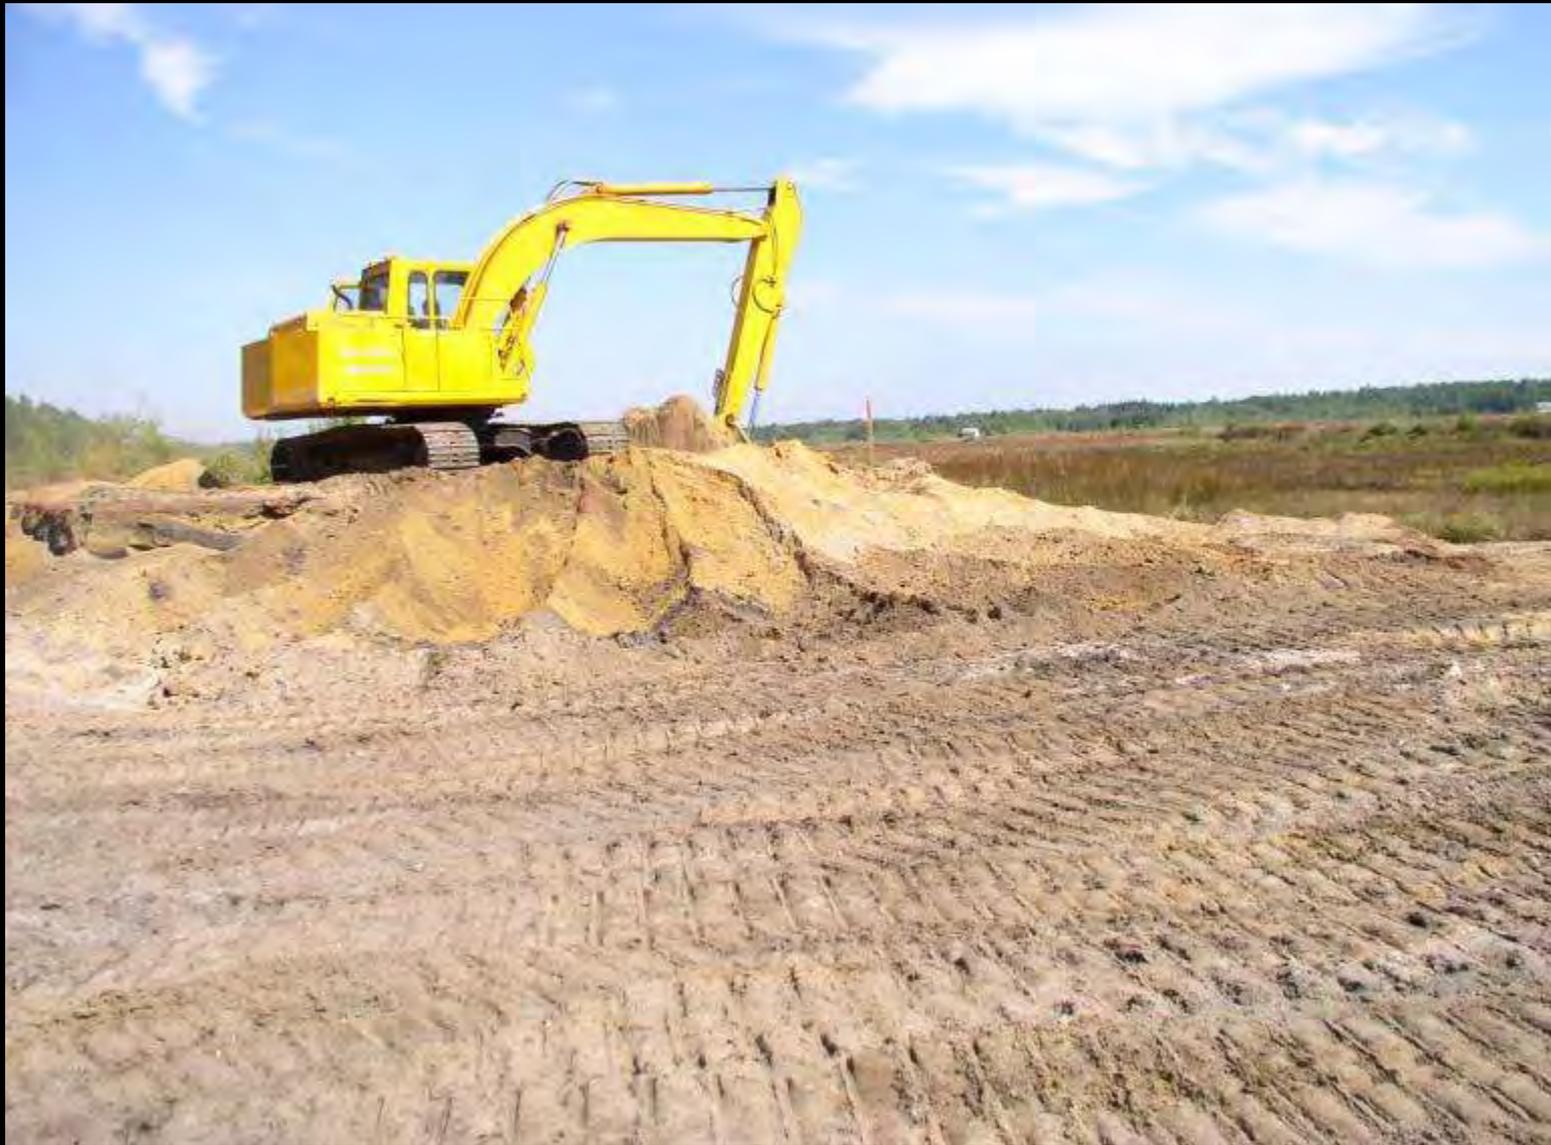
Dikes were breached to allow surface water to flow unimpeded. Without functional dikes and drainage, water is returned to its natural fluctuations.

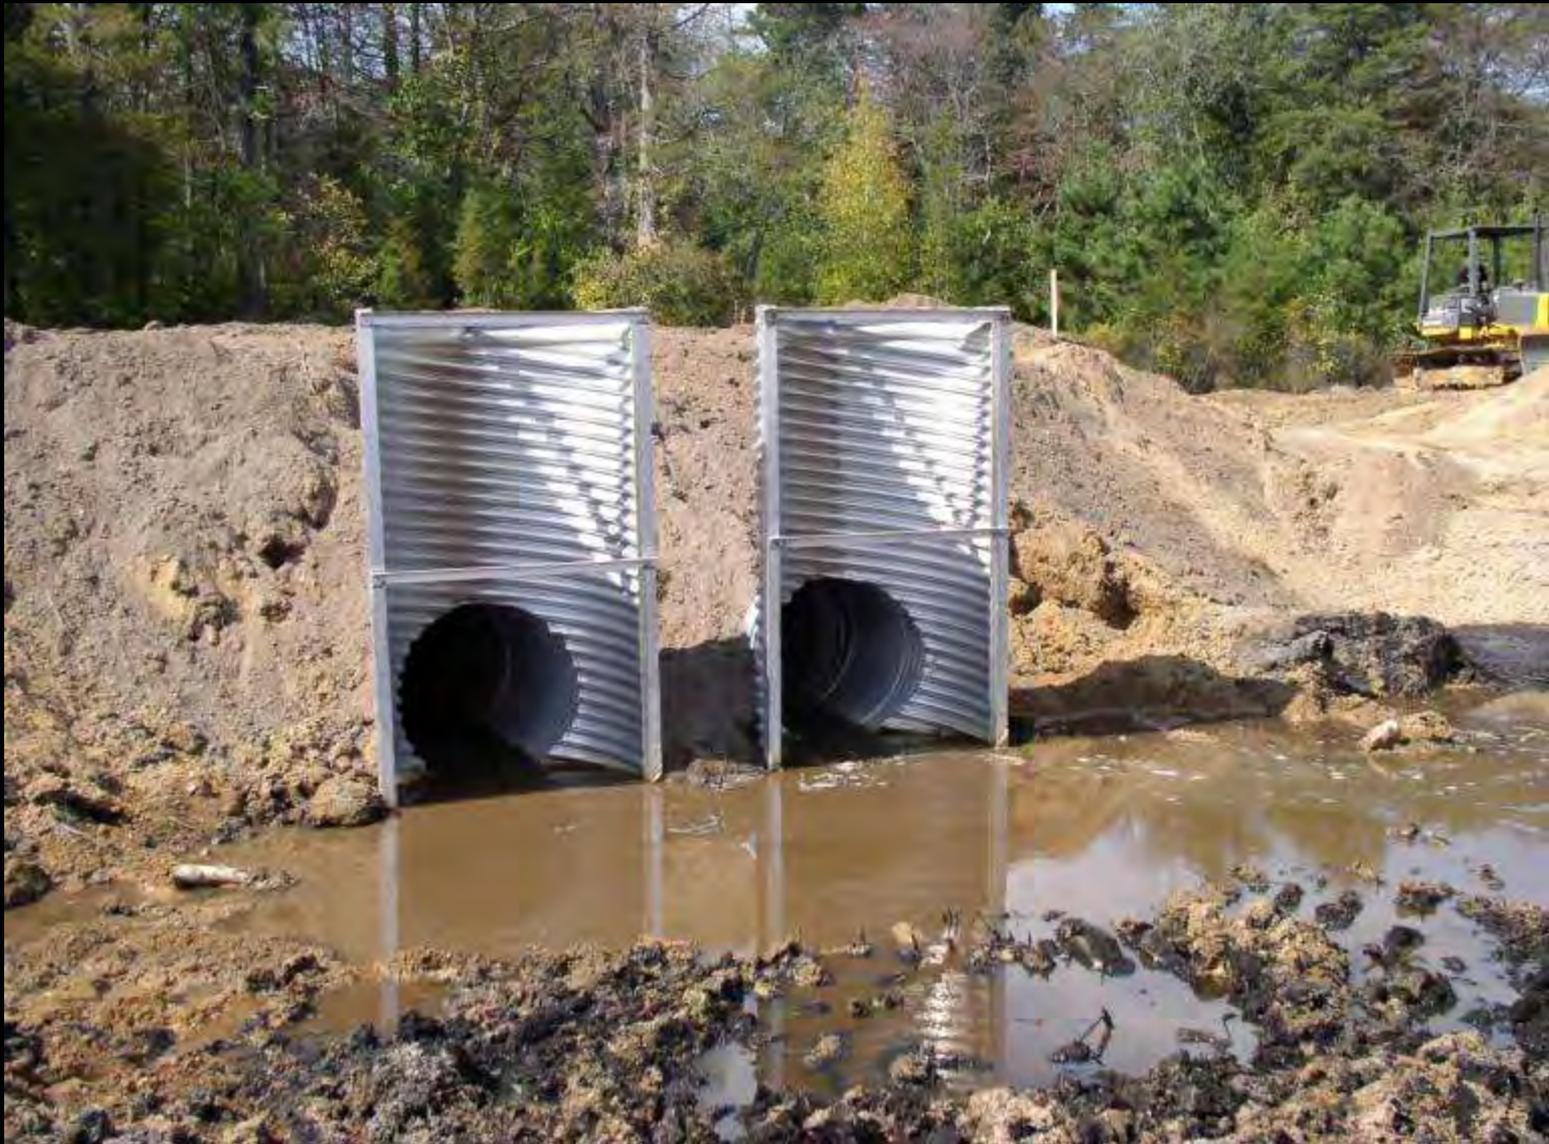
The dike at the bottom of the bog system was left to ensure that sufficient water would remain on the restoration site. Two water control structures were installed to replace the traditional wooden “trunks”.

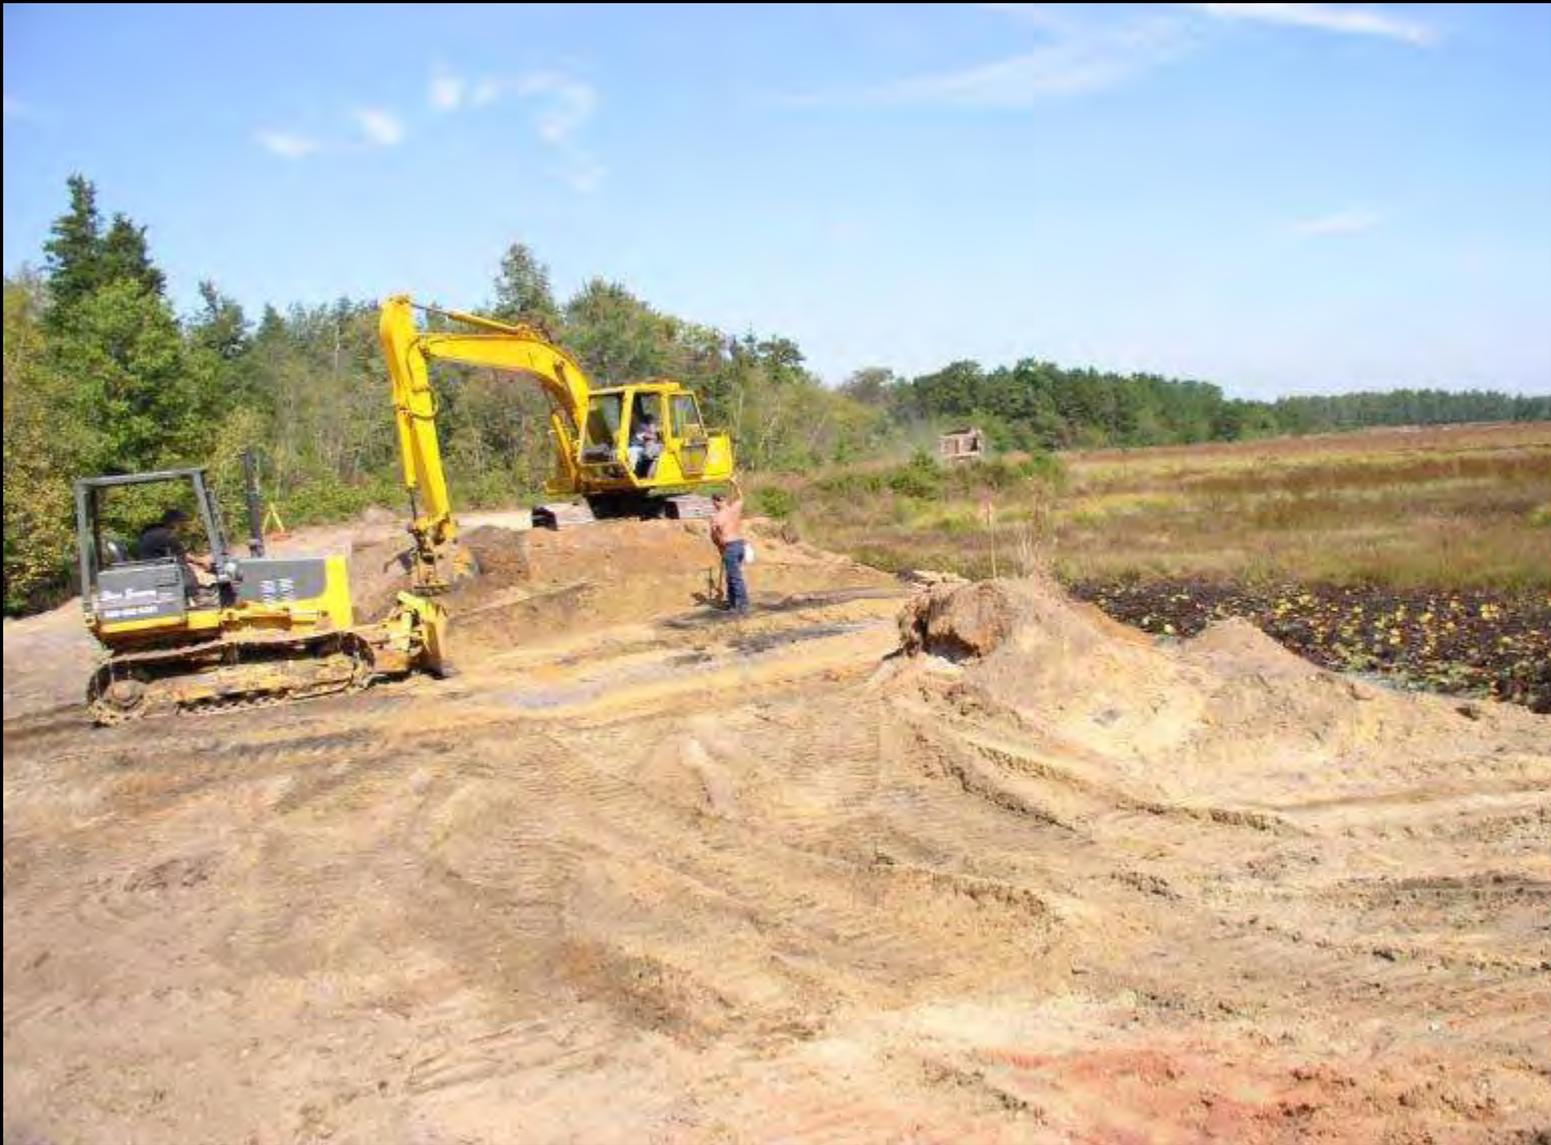
Construction of the spillway.

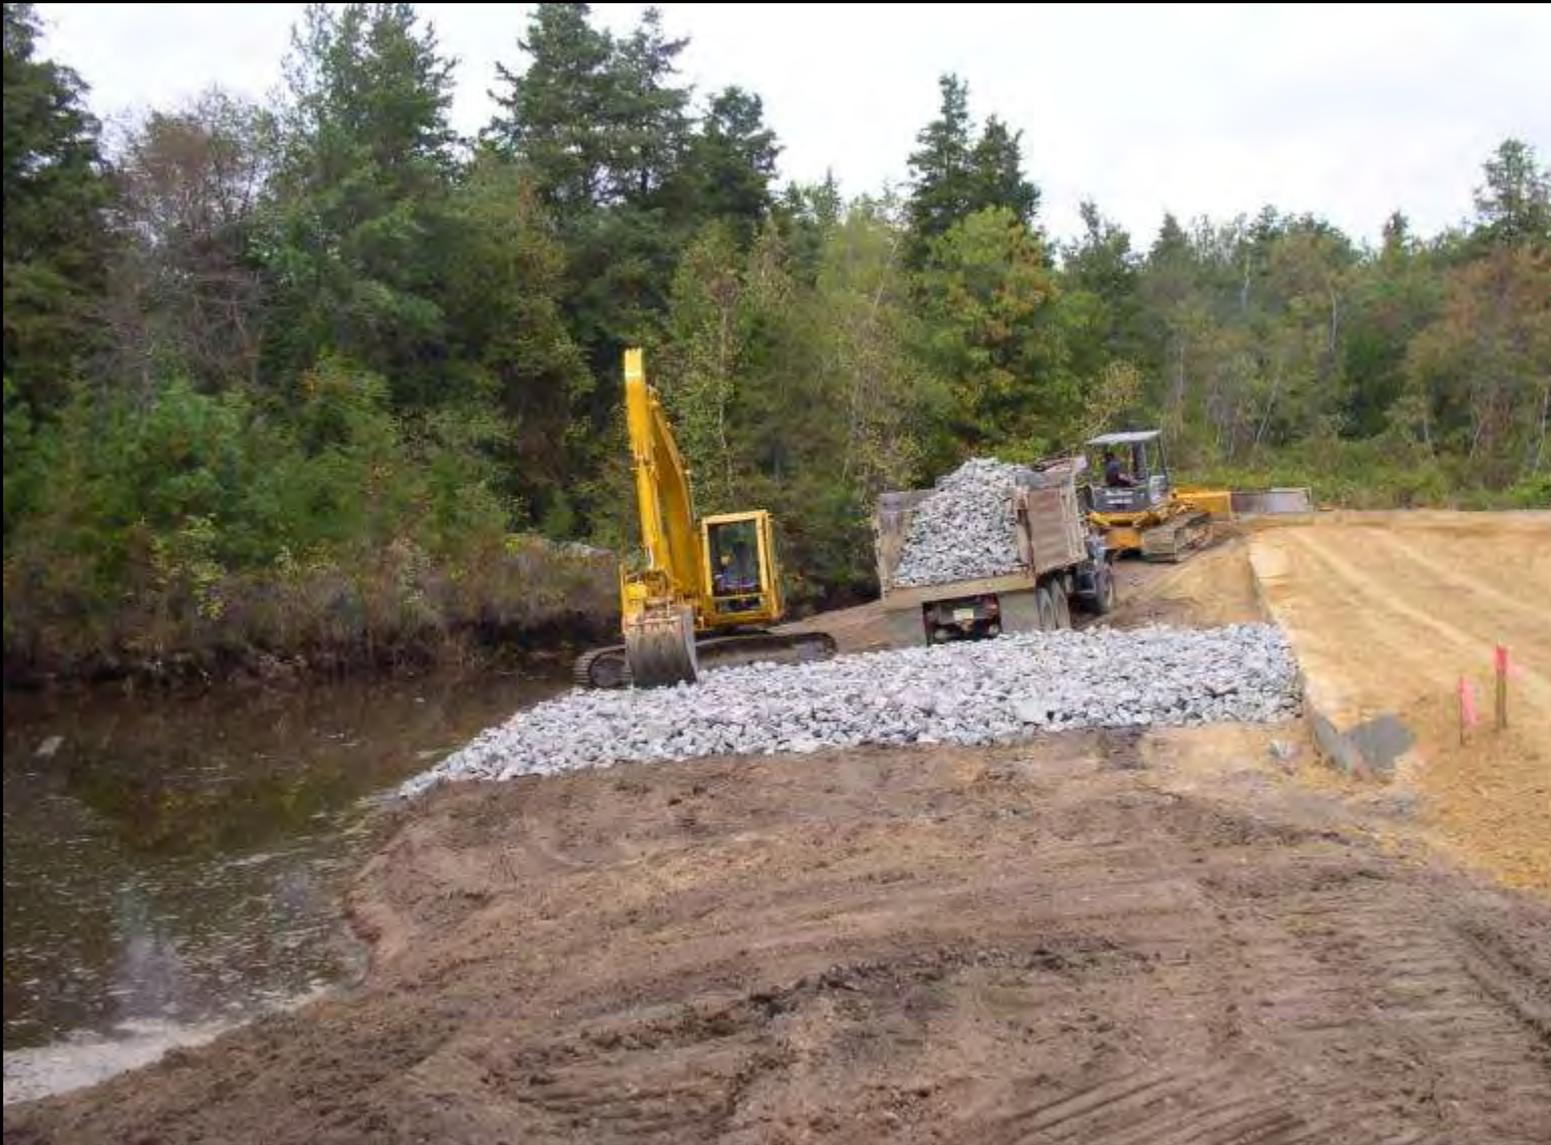
An emergency spillway was constructed to ensure that floodwaters will never breach the bottom dike.

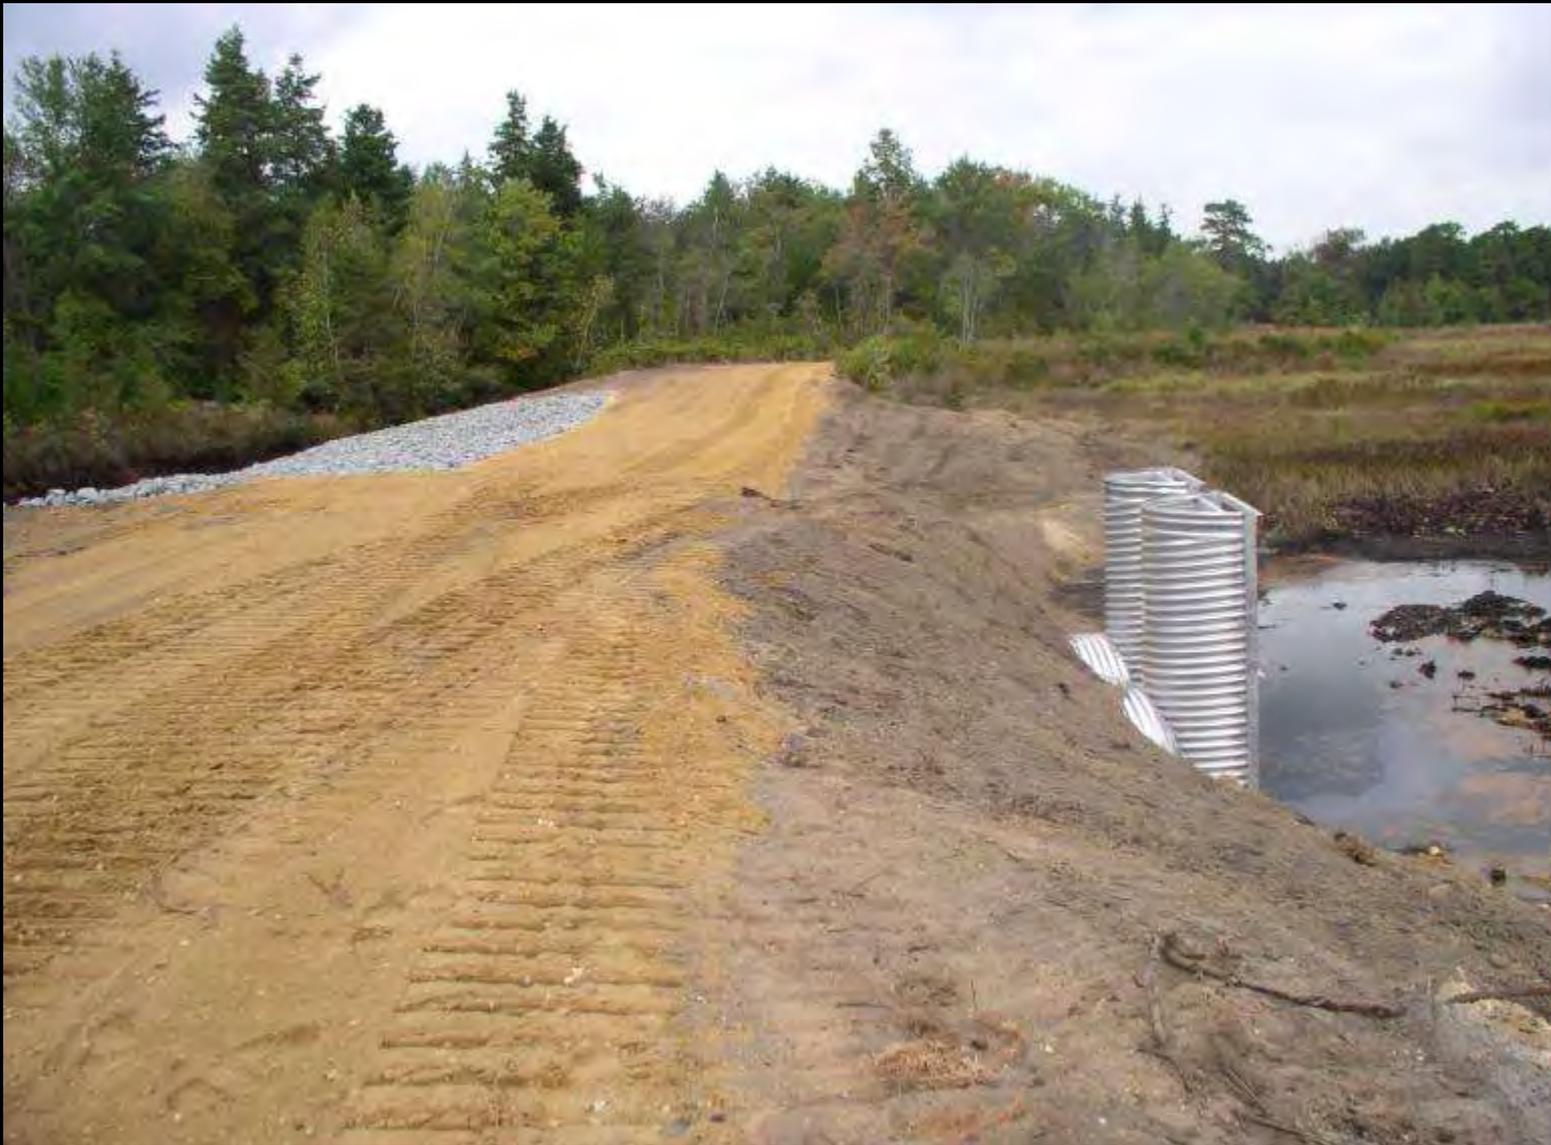
A view of the completed spillway and water control structures.

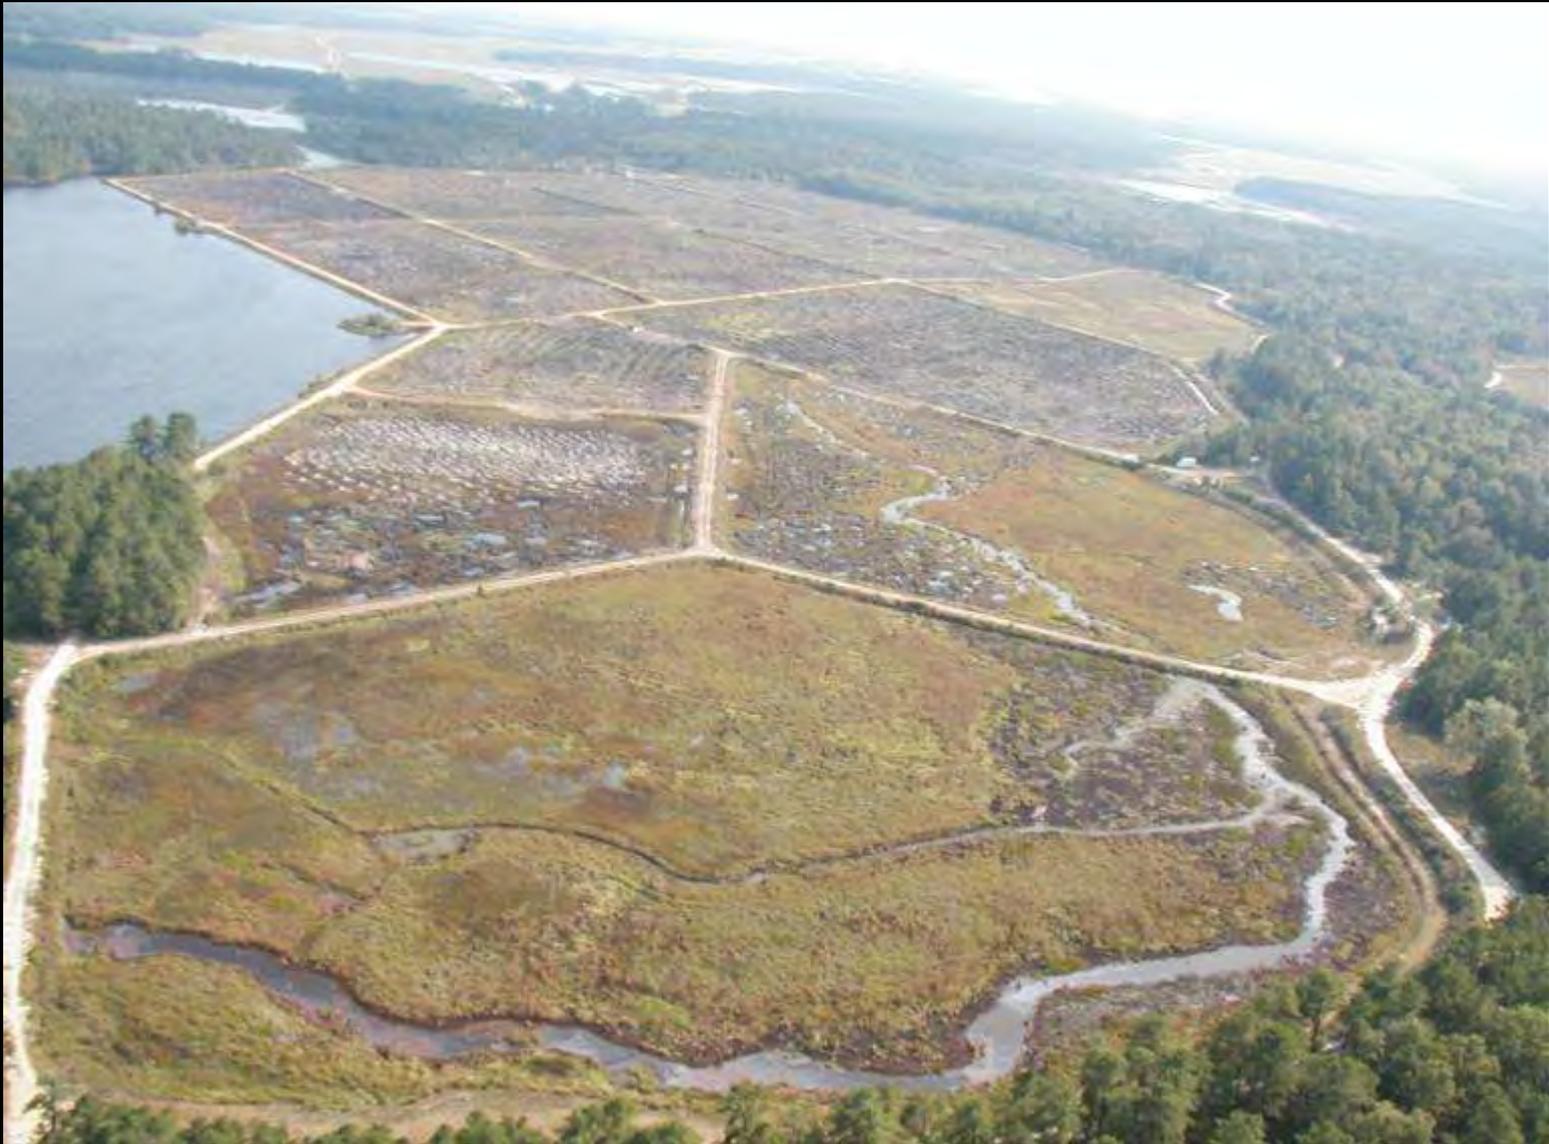
From above the topography work on the distant bogs is apparent. The bog in the foreground was too wet for our machinery.

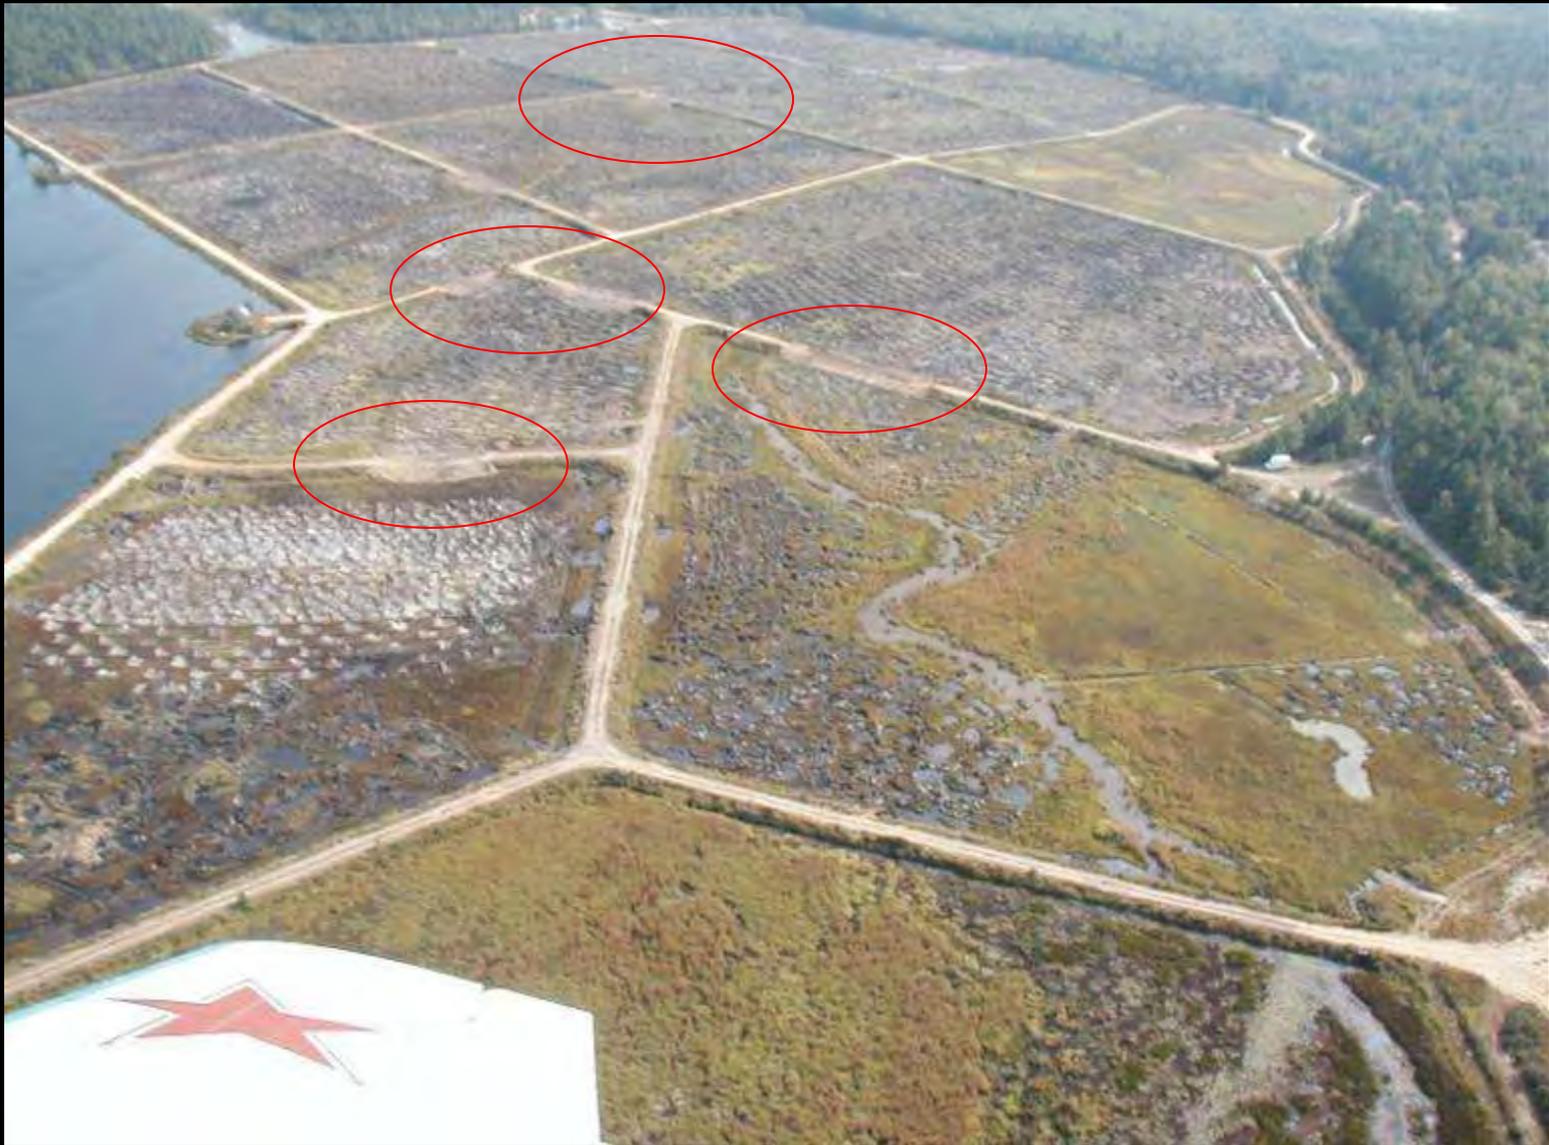
Dike breaches are easily seen in this photograph.
