**STAGE IB CULTURAL RESOURCES SURVEY
FINESVILLE DAM
POHATCONG TOWNSHIP, WARREN COUNTY AND
HOLLAND TOWNSHIP, HUNTERDON COUNTY
NEW JERSEY**

CONTRACT No. AG-2B29-C-09-0002

OCTOBER 2009

**RICHARD GRUBB & ASSOCIATES, INC.
Cultural Resource Consultants**

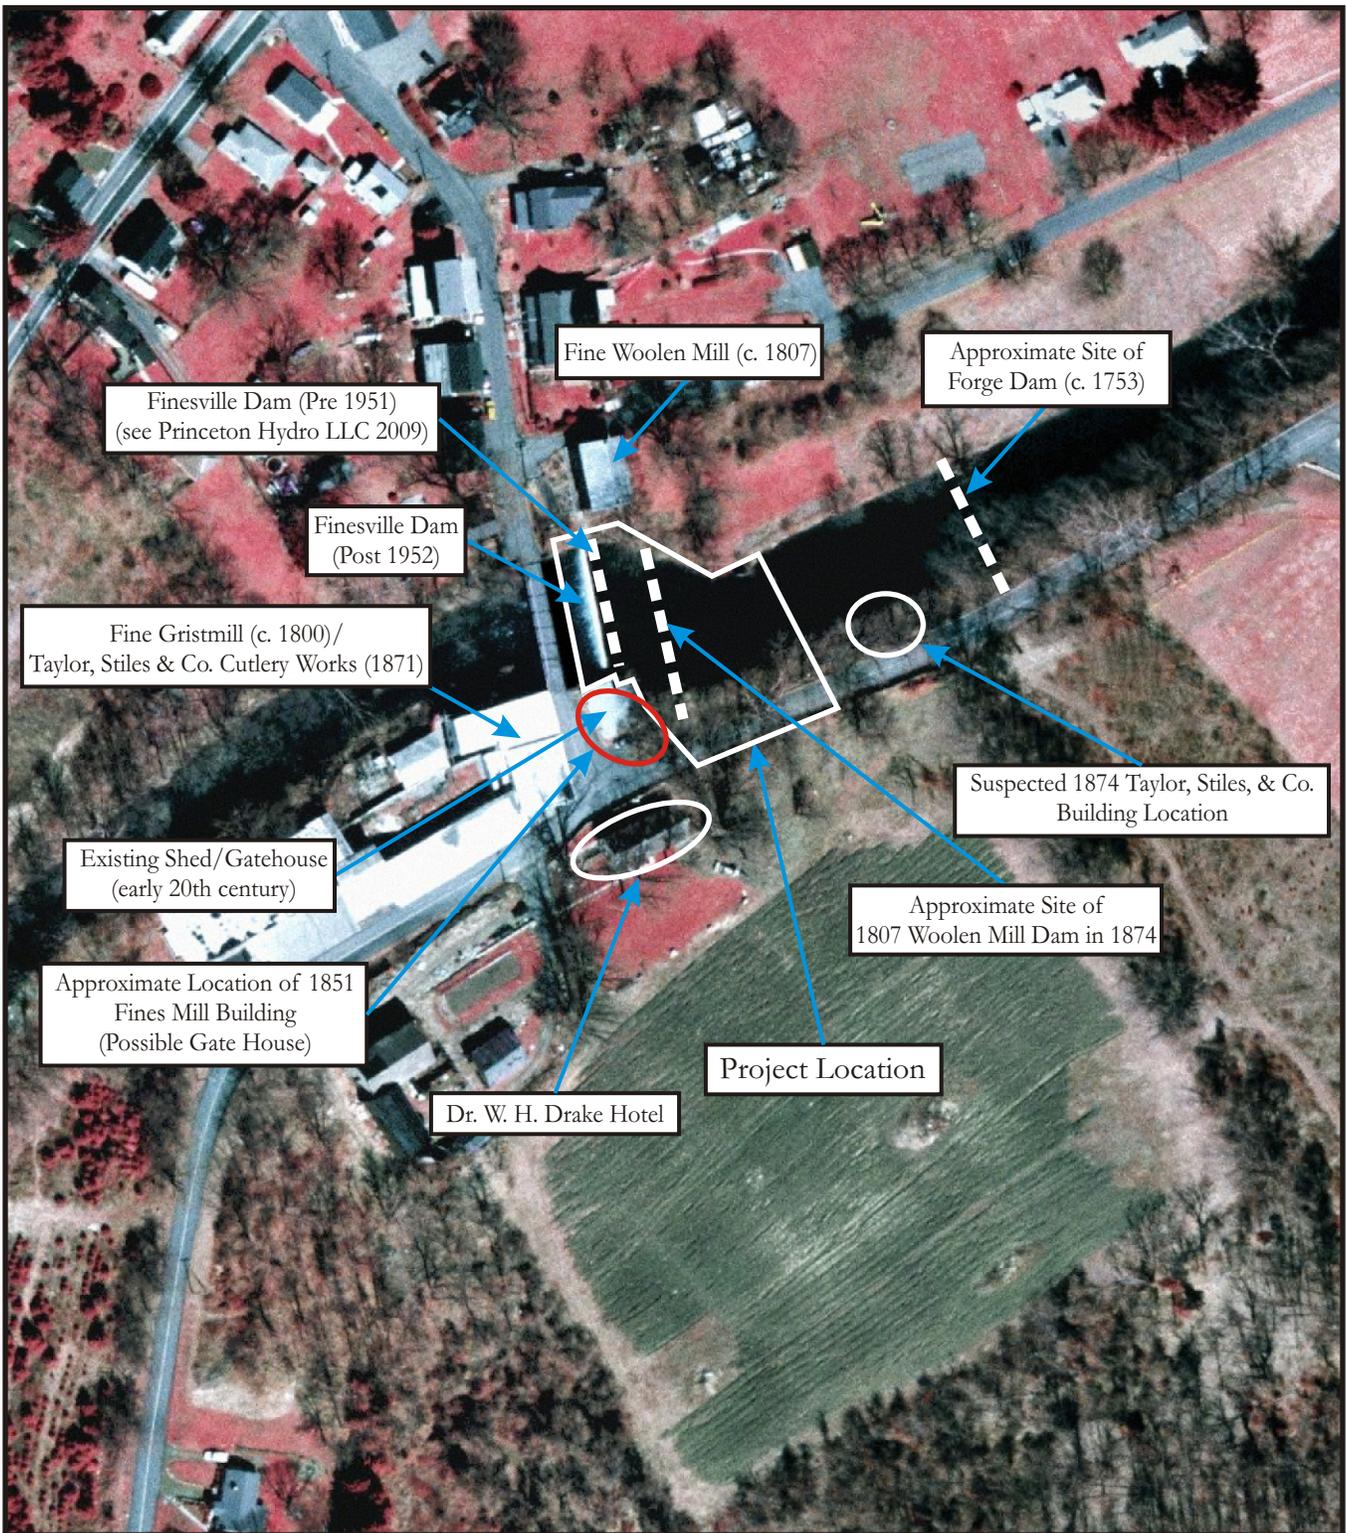
Figure 1.4:

Historic mill dams and mill related buildings
 (from U.S.G.S. New Jersey Digital Ortho Quarter Quad Aerial
 Photography, 2002: Tile Number C7D16).

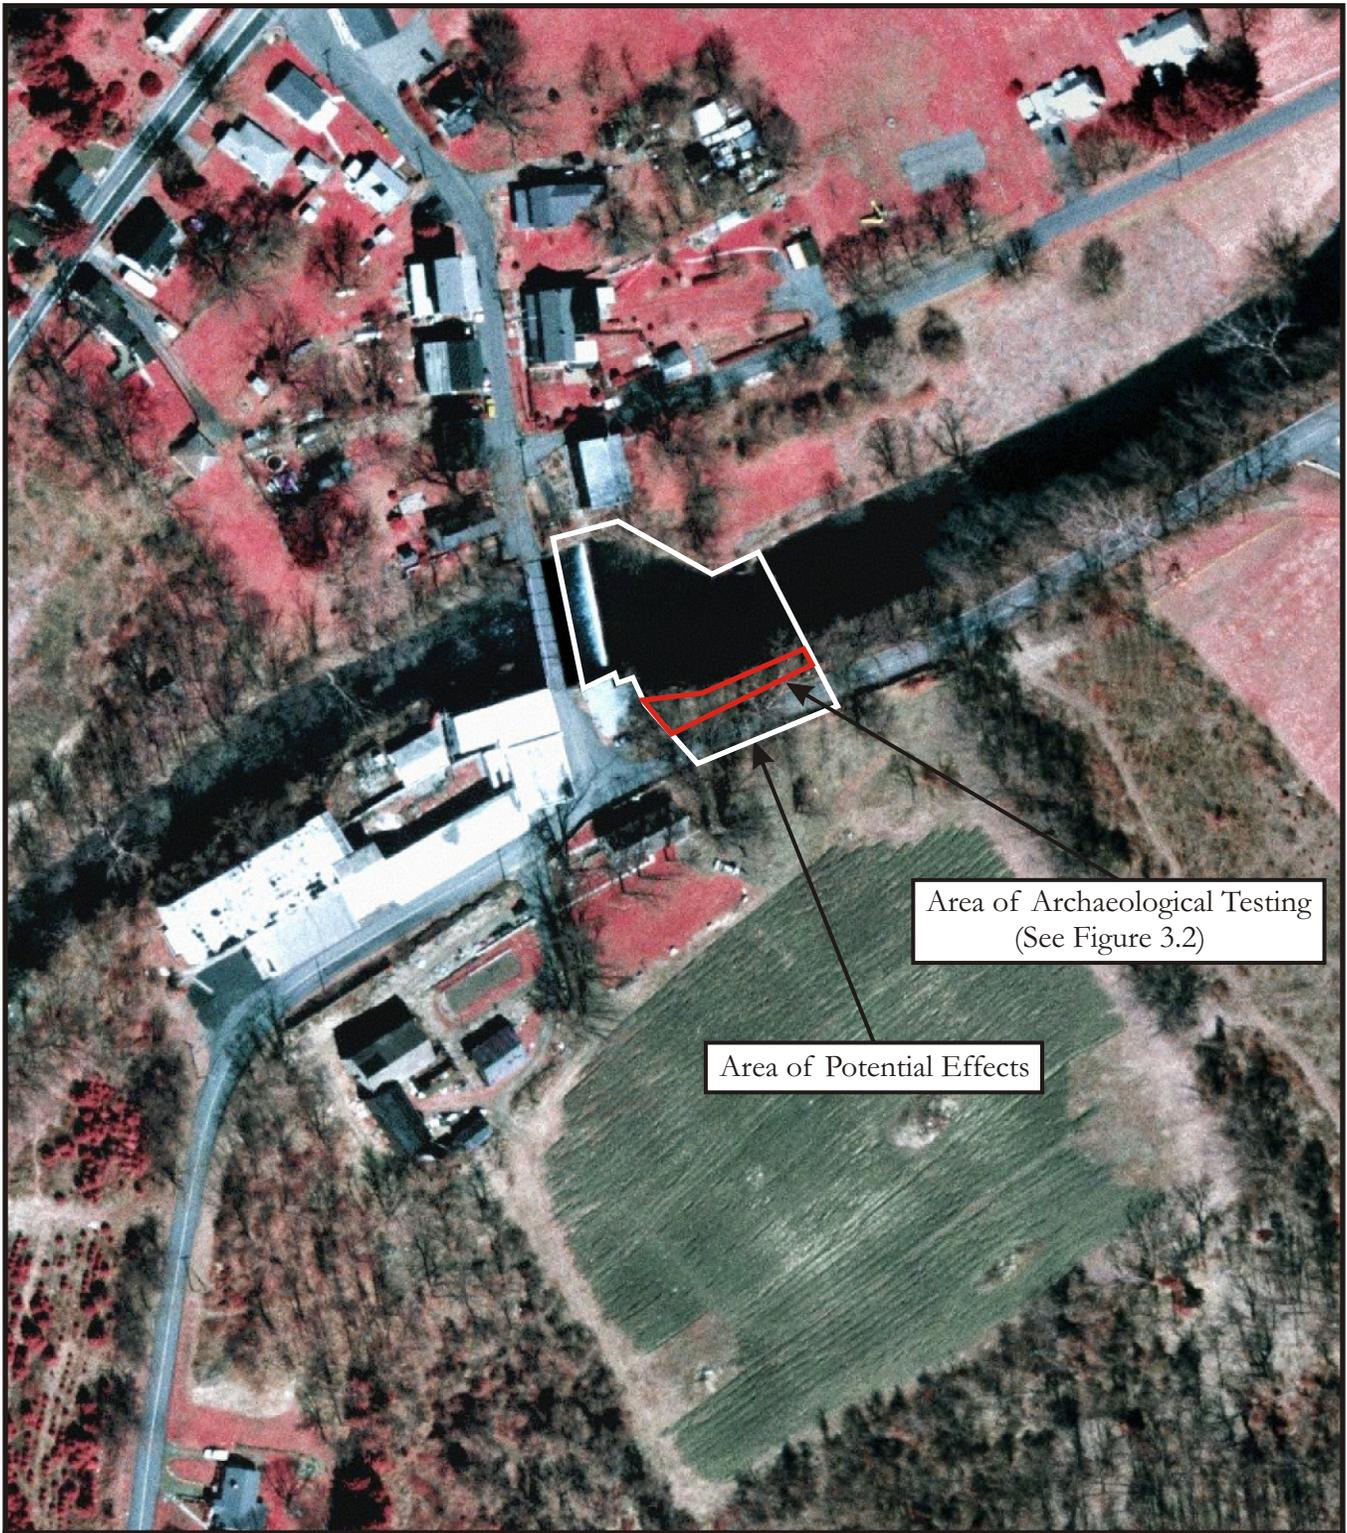
Figure 3.1:

Area of Archaeological Testing
(See Figure 3.2)

Area of Potential Effects

River within the APE, yielding 343 historic artifacts (see Appendix C; Figures 3.1 and 3.2; Plate 3.1). No archaeological testing was conducted on the Bellis Road or Musconetcong River embankments, which contained slopes of 55% or greater. The APE consisted of a narrow terrace that tapered toward the east (Plate 3.2). Due to the presence of the river embankment, the historic raceway alignment, portions of which are exposed within the footprint of an adjacent shed, was not archaeologically tested (see Figure 3.2).

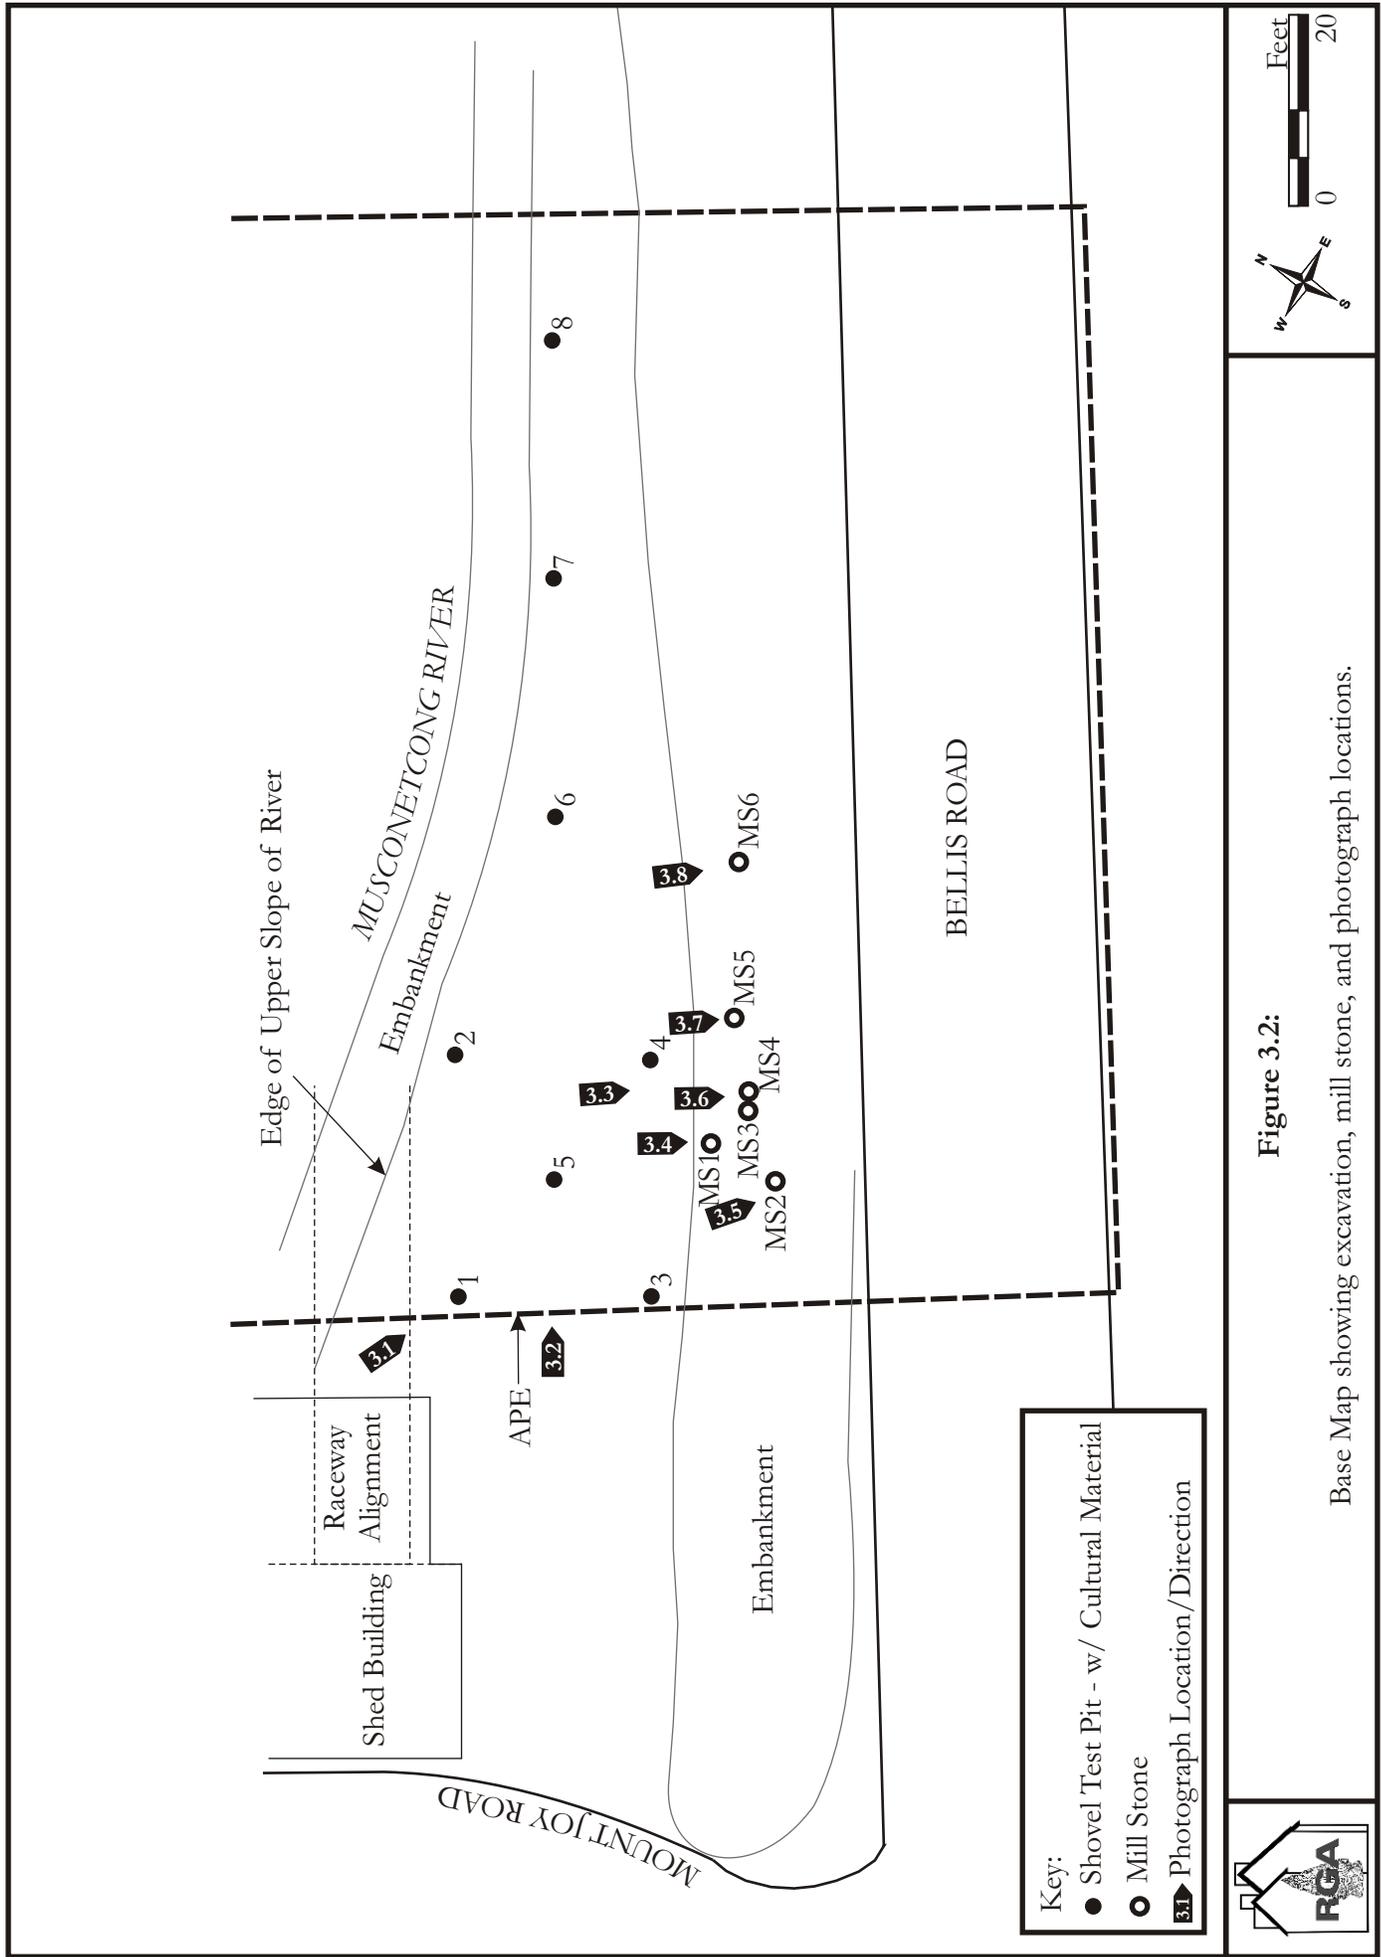
Figure 3.2:

Base Map showing excavation, mill stone, and photograph locations.

During the Stage IB survey, six exposed sandstone millstones were observed within the north side of the Bellis Road embankment (see Figure 3.2; Plates 3.3-3.8). The millstones varied in size and shape. Millstone 1 measured roughly 2.3 feet in diameter. Its thickness could not be determined. Millstone two was partially exposed and measured 0.6 feet thick. Millstones 3 and 4 were conical in profile, measuring 1.1 feet thick with a top diameter of 1.7 feet and a bottom diameter of 1.9 feet. Millstone 5 measured 2.5 feet in diameter and contained circular grooves in its face. Only a fragment of Millstone 6 survived. Its true dimensions could not be ascertained. Where exposed, the millstones contained square central holes that measured between 0.4 and 0.6 feet square. These millstones were once part of an extensive linear deposit of millstones that stretched for several hundred feet along the north embankment of Bellis Road (see Appendix D). Most of the millstones were removed over the years by local inhabitants, leaving only six exposed in the embankment. Discussions with property owner Jim Grodon indicated that these millstones were likely associated with the Taylor, Stiles, & Company knife mill that operated on the west side of Mount Joy Road from the 1870s to the 1890s (Appendix D). The millstones were likely deposited after they broke from use and/or after the mill ceased its operation.

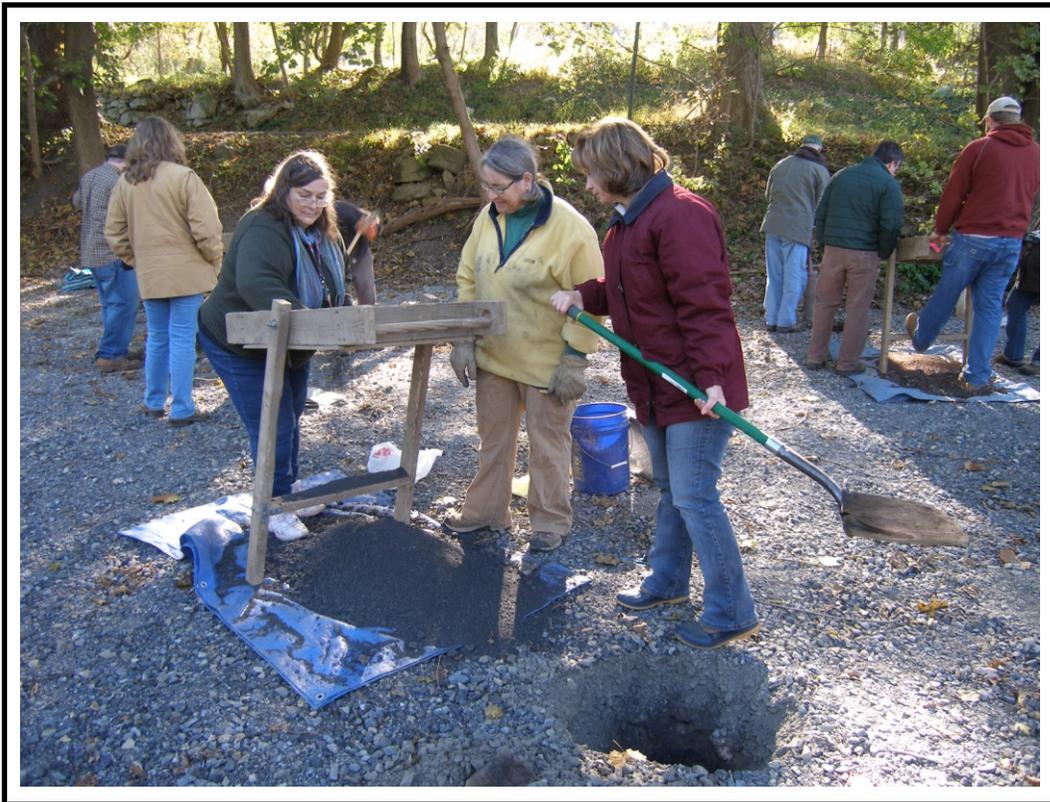
Plate:
3.1

Overview of NRCS staff assisting with Stage IB archaeological excavations.

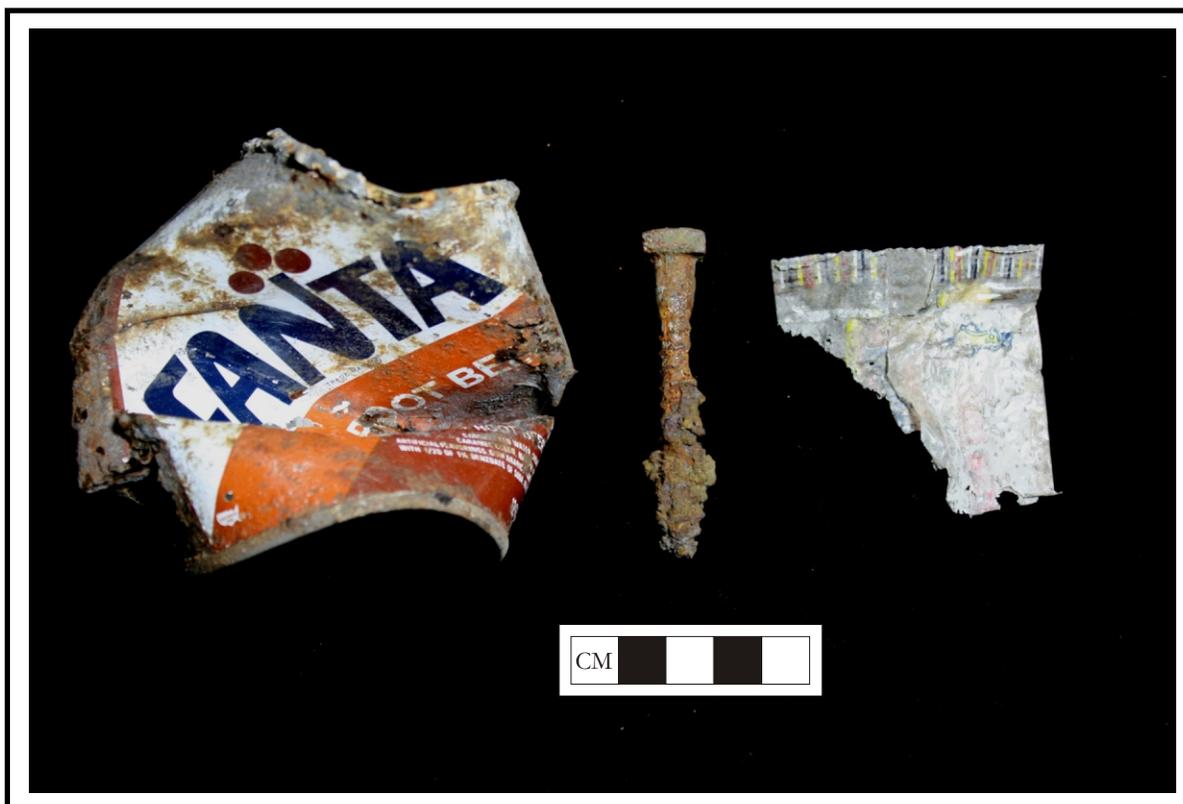
Figure 3.3:

Representative artifacts recovered from STP 2.

Left to Right: Fanta Soda Can, Screw Bolt, Planter's Peanuts Wrapper (Cat.# 2).

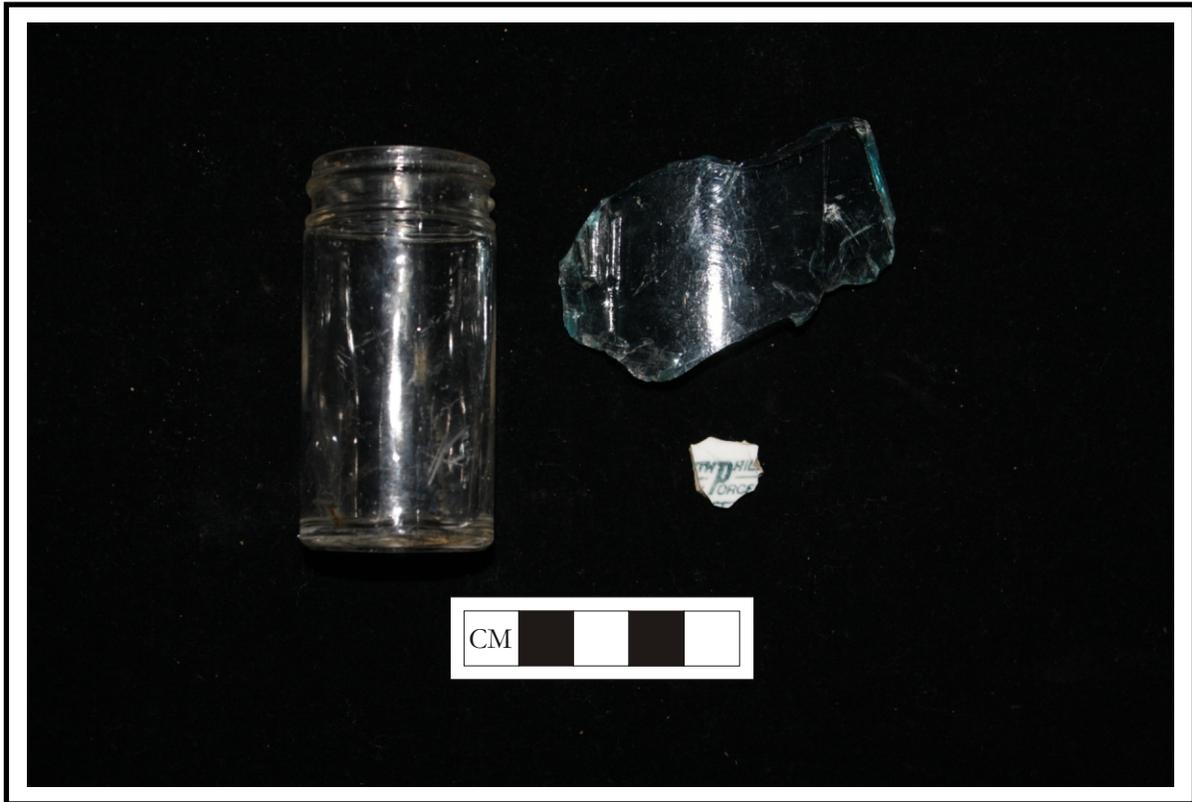
Figure 3.4:

Representative artifacts recovered from STP 4.

Left to Right: Colorless Bottle, Aqua Bottle, Ceramic Vessel Fragment (Cat.# 7).

Shovel test pits 1, 2, 6, 7, and 8, were plotted near the terrace's northern edge. Of these, STPs 1, 2, 6, and 7 contained similar stratigraphy, which generally consisted of a modern soil/gravel layer over a three to five-foot thick layer of re-deposited black (10YR 2/1) to very dark gray (Gley 1 N 3/) river bottom silt (deposited during the twentieth century), over a late-nineteenth to early twentieth-century brown (10YR 5/3 and 10YR 4/3) silt loam. With the exception of STP 8, which was stopped by a rock impasse one-foot below ground surface, the remainder of the STPs excavated closest to the river bank extended five to six feet below ground surface, beyond the depth permitted by hand shovel and auger testing. The depth of this testing also exceeded the elevation of the river's current surface level. Examination of historic maps also suggests that the location of STPs 1, 2, 6, 7, and 8 were within the footprint of the water's edge based on an 1874 map of Finesville (Richard Grubb & Associates, Inc. 2009: Figure 4.8; Beers 1874). The layer of thick, re-deposited river bottom soil may have been placed within the APE following the 1952 flood event which destroyed the ca. 1874 to 1952 wooden cribbing dam. The deposit suggests that this portion of the APE may have been used as a construction staging area during the construction of the 1952 dam. Artifacts recovered from this soil layer generally consisted of coal, coal slag, cement, metal screws, a Fanta soda can, and a Planter's Peanuts plastic wrapper (Figure 3.3). The brown silt loam soil layer found below the re-deposited river soils in STP 6 contained a discrete deposit of 21 mid to late-nineteenth-century artifacts, including a stoneware pot rim, whiteware, white granite, window glass, brick and colorless (Post 1860s) and solarized vessel glass (1880-1920s) (Figure 3.4) (see Appendix C).

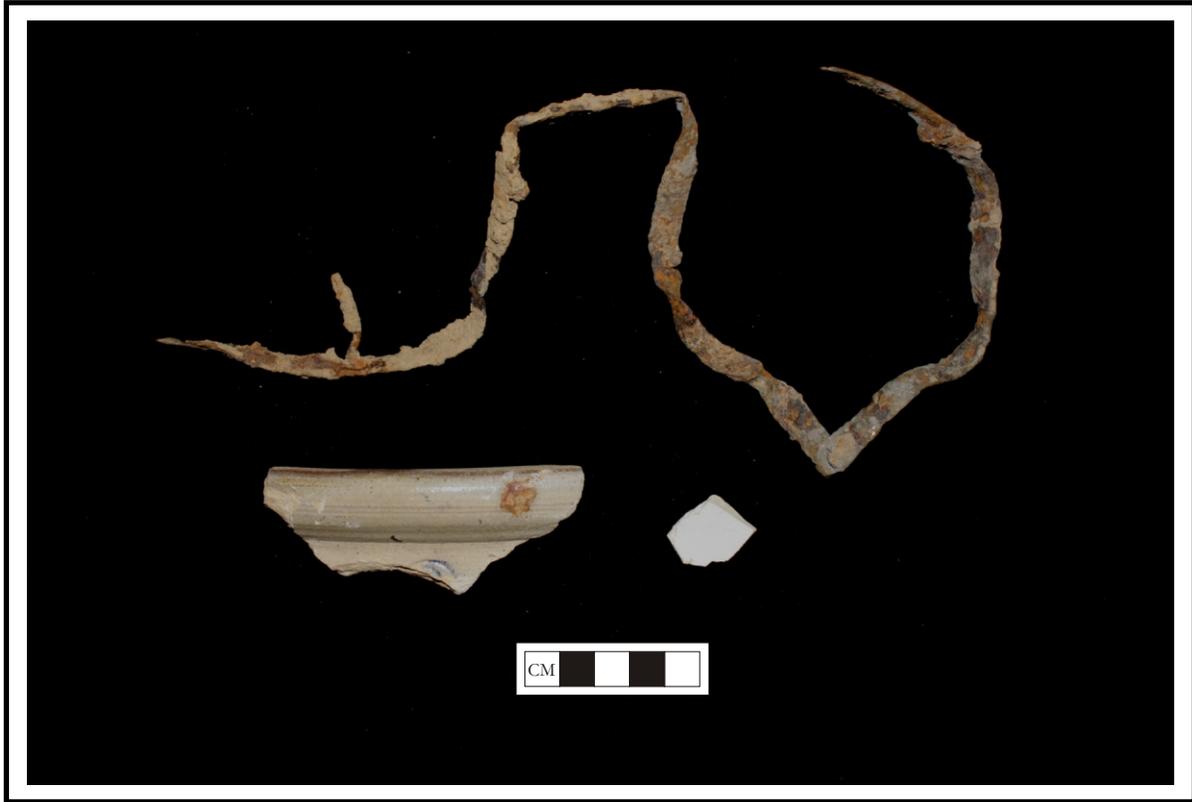
Figure 3.5:

Representative artifacts recovered from STP 6.

Top to Bottom: Metal Strap, Stoneware Pot Rim, Whiteware Fragment (Cat.# 12).

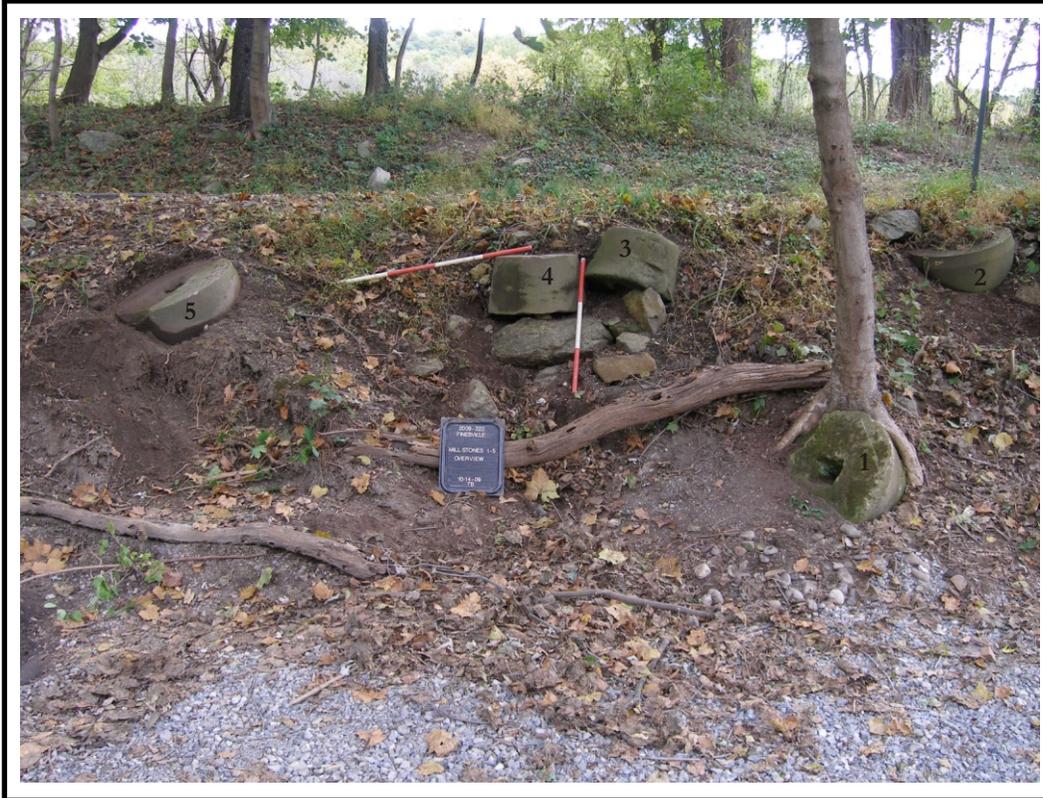
Plate:
3.3

Overview of the APE showing mill stones 1-5 in the Bellis Road embankment.

opposite side of Bellis Road. If the proposed alternatives of partial dam breach or full dam removal are chosen, given the depth of the deposits (i.e. beginning at and extending past three feet below ground surface), RGA recommends that archaeological monitoring be undertaken along the south bank of the Musconetcong River within the APE in order to document additional mid-to-late nineteenth-century cultural deposits, if present. Archaeological monitoring of construction activities should also take place within the APE along the south bank of the Musconetcong River to document the remains of nineteenth-century head race channels, if extant. Further, as indicated in the previous Stage IA cultural resources survey, RGA (2009) recommends that archaeological monitoring be undertaken during construction activities to document the existing dam, as well as the remains of earlier dams within the APE, including, but not limited to, the 1807 woolen mill dam and the ca. 1874 to 1952 wooden cribbing dam. It should be noted that lowering the water level within the APE through partial breach or full dam removal may expose the remains of earlier wooden timber and stone dams, like the two mentioned above, within the Musconetcong River section of the APE (see Figure 1.4). Long term exposure of wooden timber archaeological dam elements could have an adverse effect on those archaeological resources, if present. Therefore, recordation and dendrochronological studies of those archaeological features, if possible, is recommended in order to ascertain construction dates and methods. It is recommended that such recordation take place immediately following construction activities. Finally, RGA recommends that care be taken to avoid disturbance to the north side of the Bellis Road embankment and destruction/removal of the remaining millstones in the embankment.

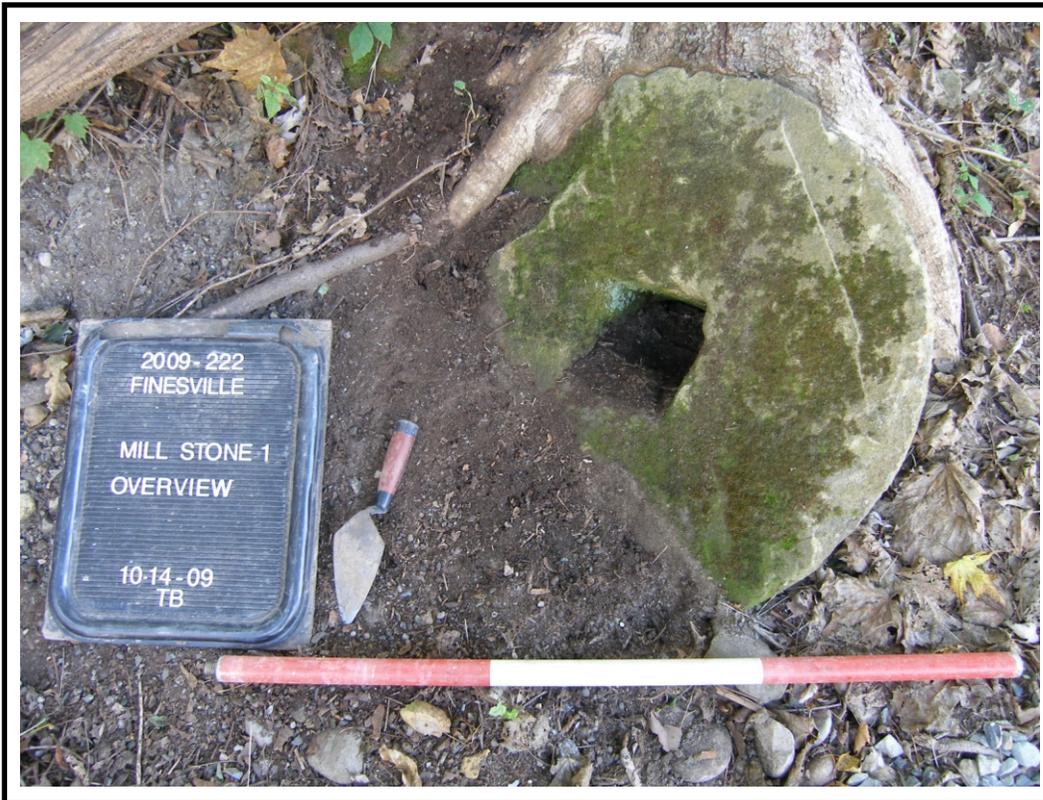
Plate:
3.4

Plan view of Mill Stone 1.

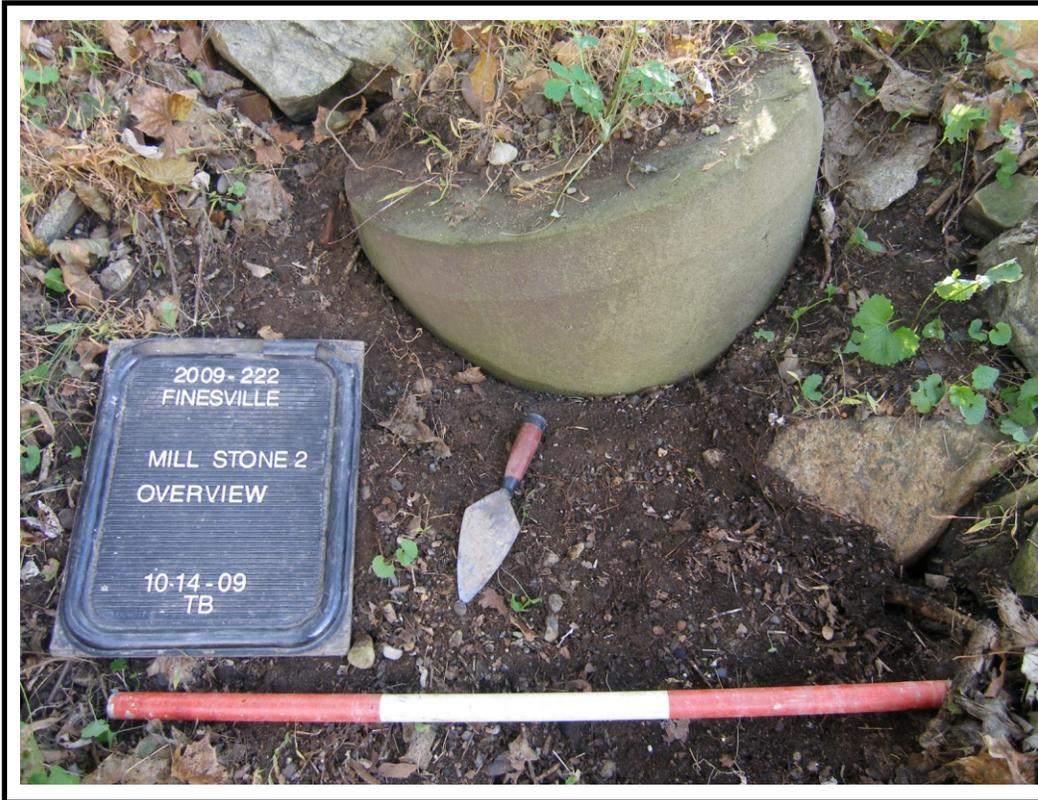
Plate:
3.5

Profile of Mill Stone 2. Note beveled side.

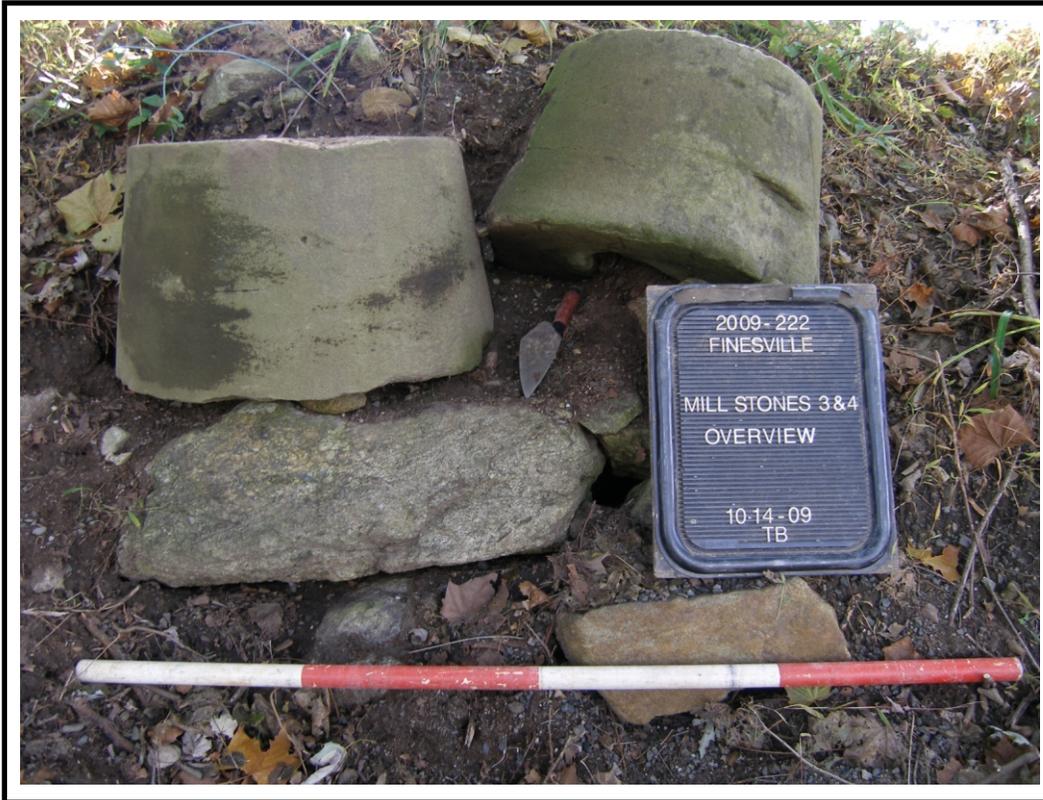
Plate:
3.6

Profile of Mill Stones 3 and 4.

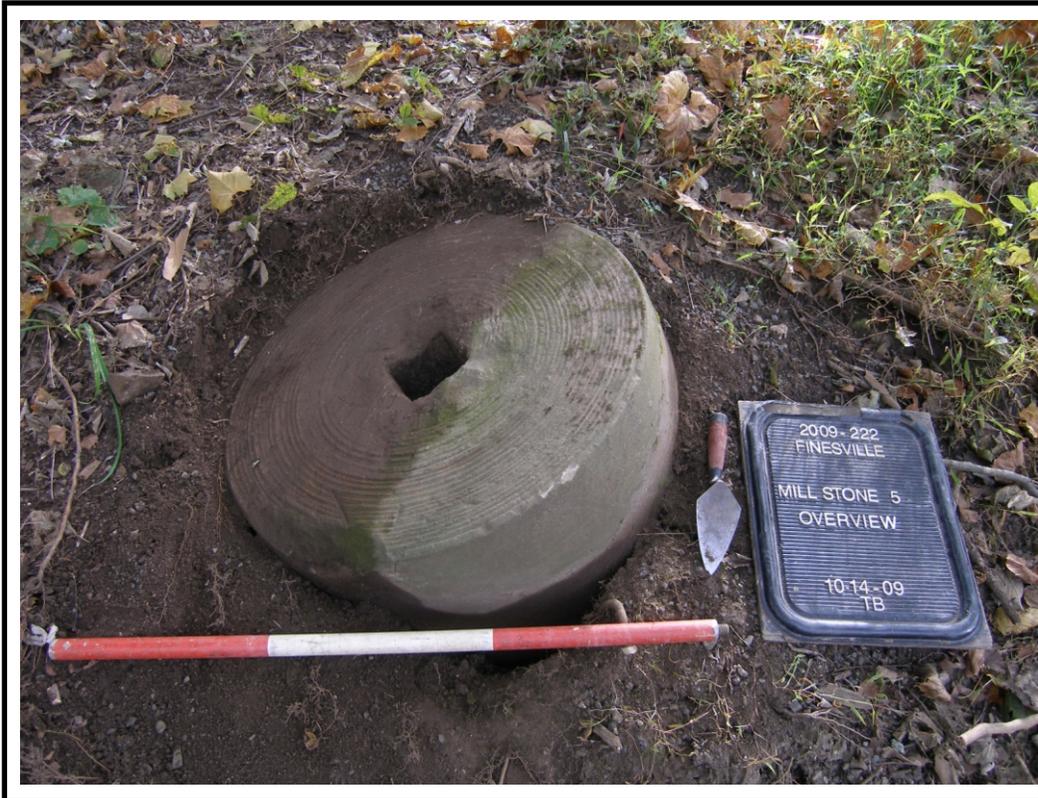
Plate:
3.7

Plan view of Mill Stone 5.

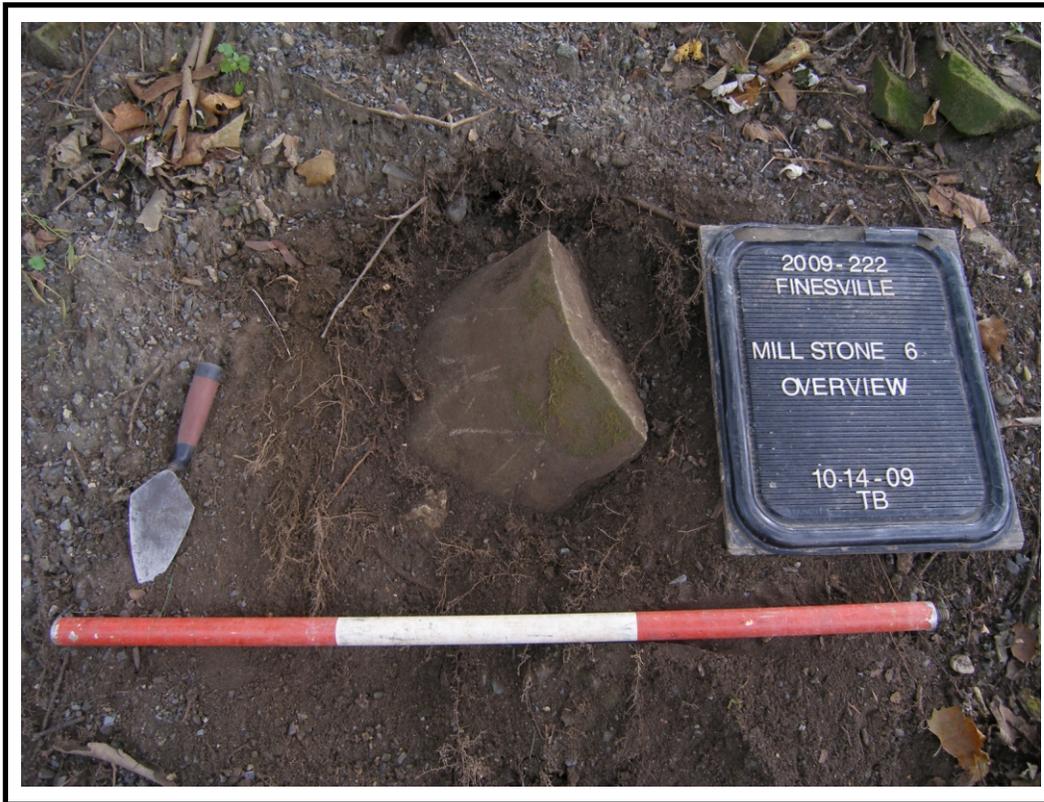
Plate:
3.8

Partial profile of Mill Stone 6. Note, Mill Stone 6 was fragmented.
